HISTORIC STRUCTURE REPORT:
THE CUSTOM HOUSE AND TOWER

VOLUME II:
EXISTING CONDITIONS AND RECOMMENDATIONS

SARA B. CHASE
and
ANNE A. GRADY

SOCIETY FOR THE PRESERVATION OF
NEW ENGLAND ANTIQUITIES
CONSERVATION CENTER

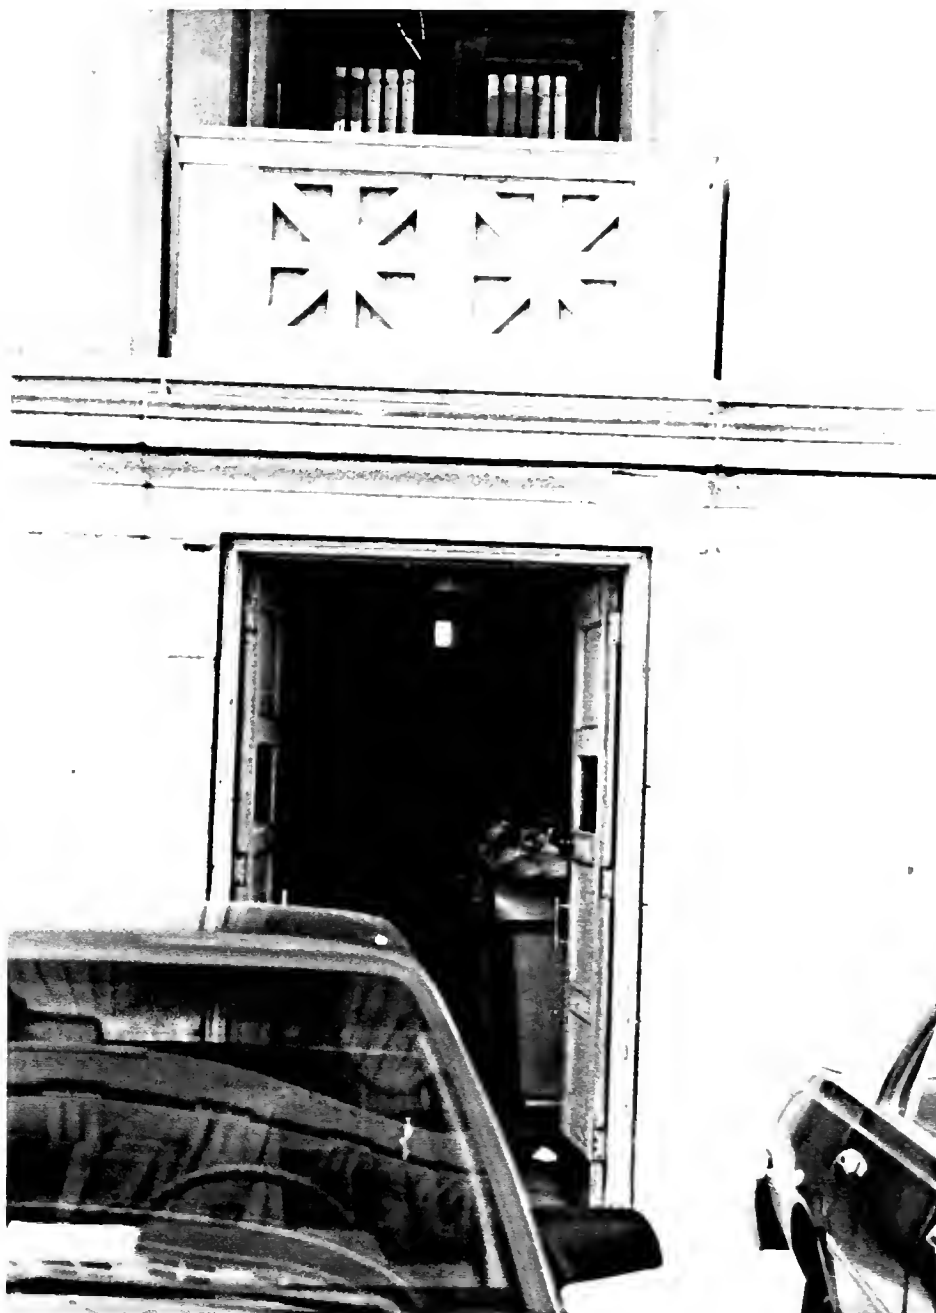
Figure 5

South side, street level
Typical condition of all window lintels.

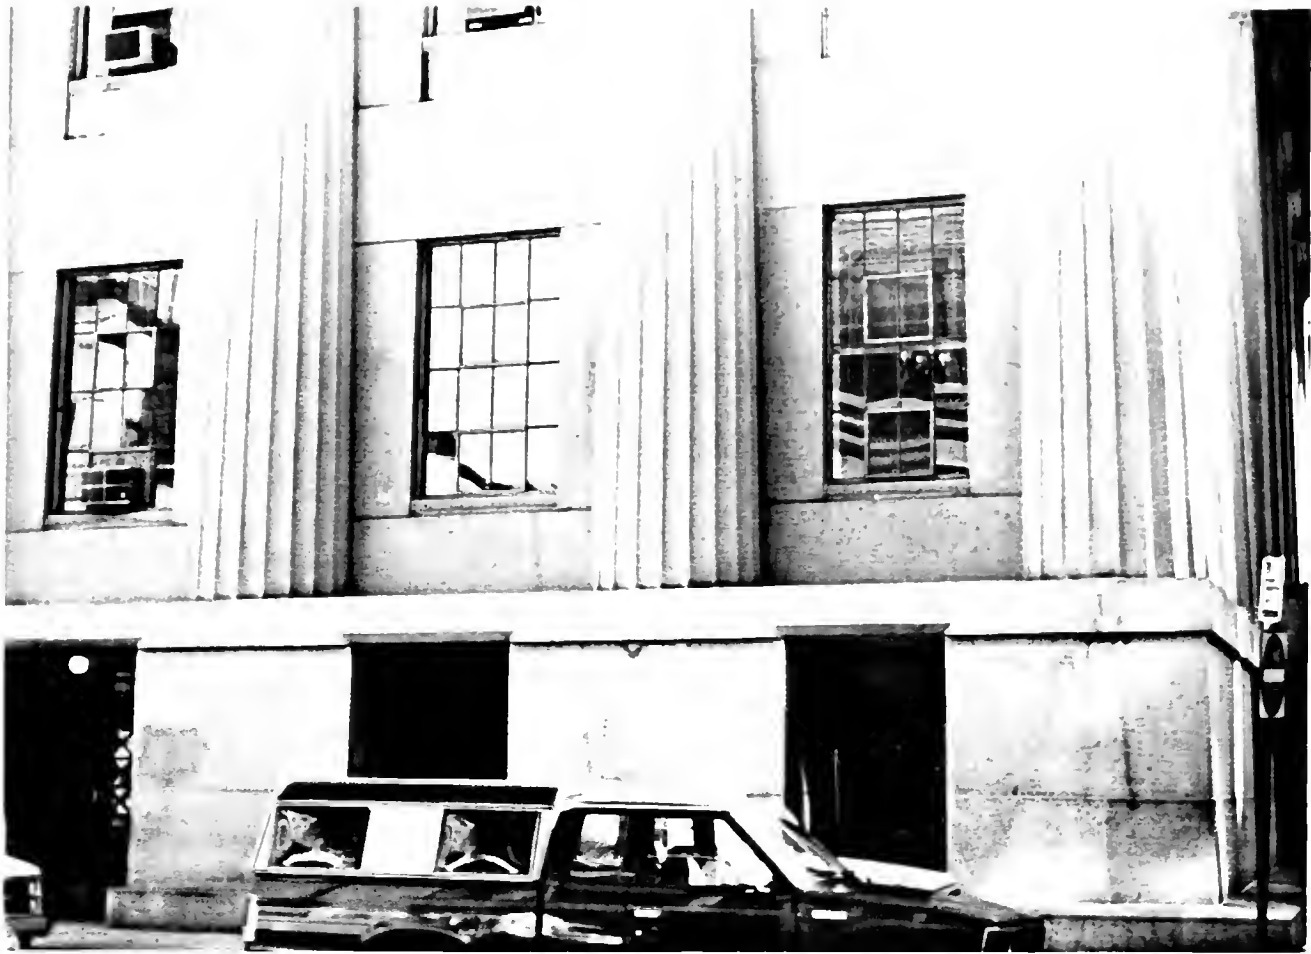
Figure 6

East entry, basement level

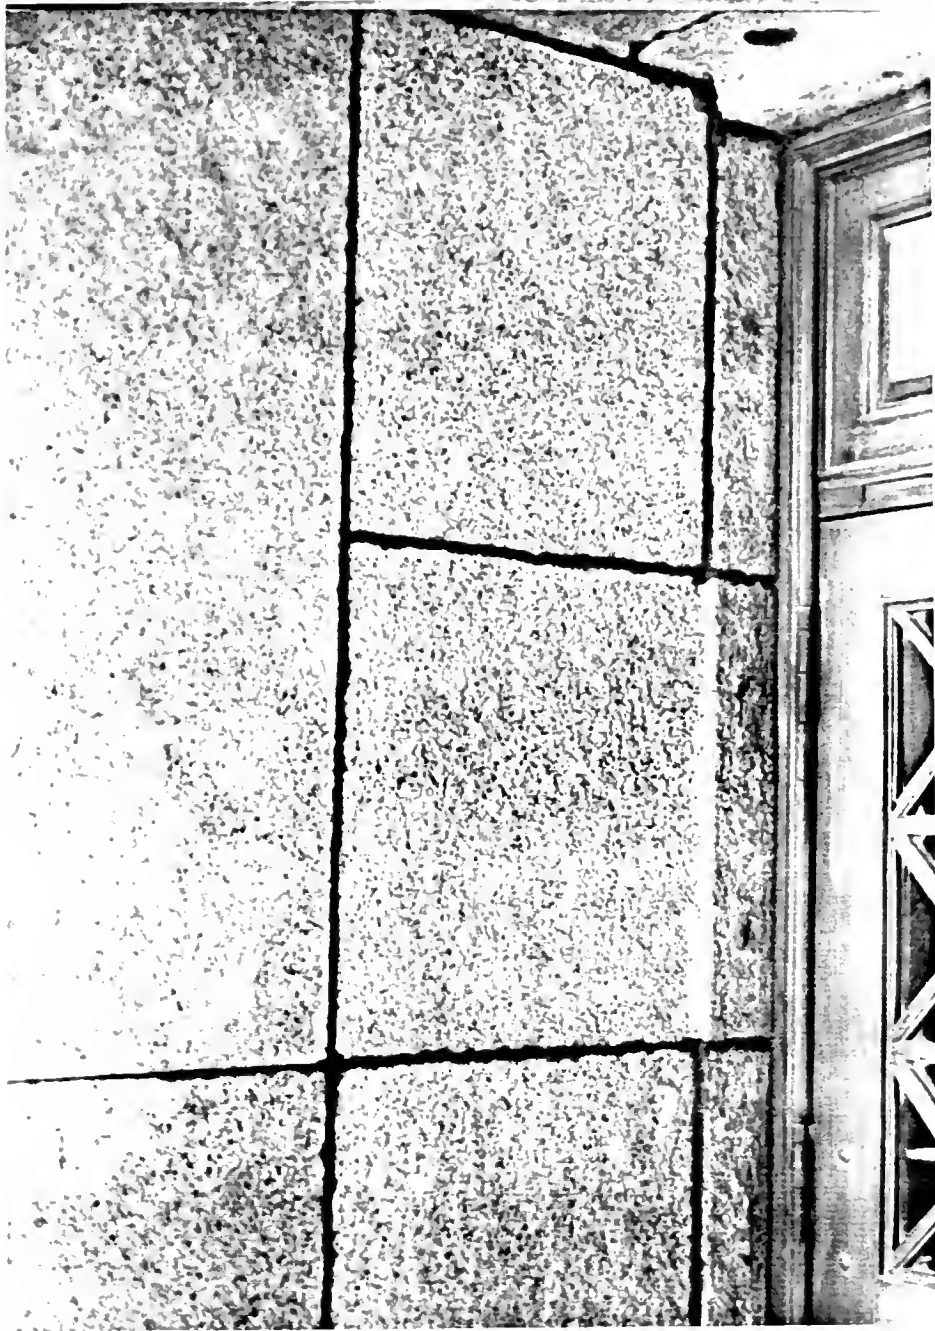
Figure 8

North basement entry

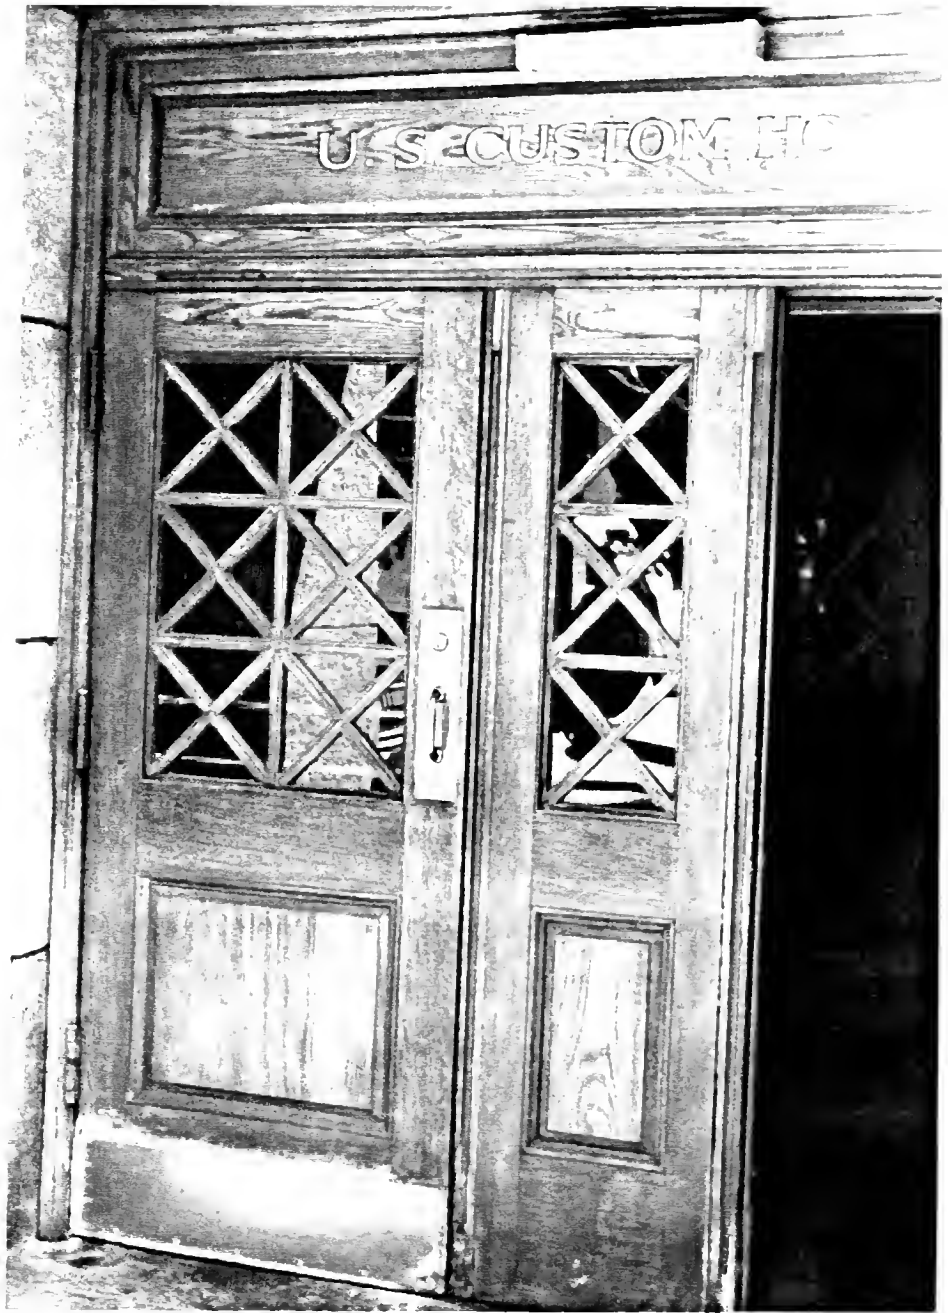
Figure 9

Black caulk at East side of
North basement entry

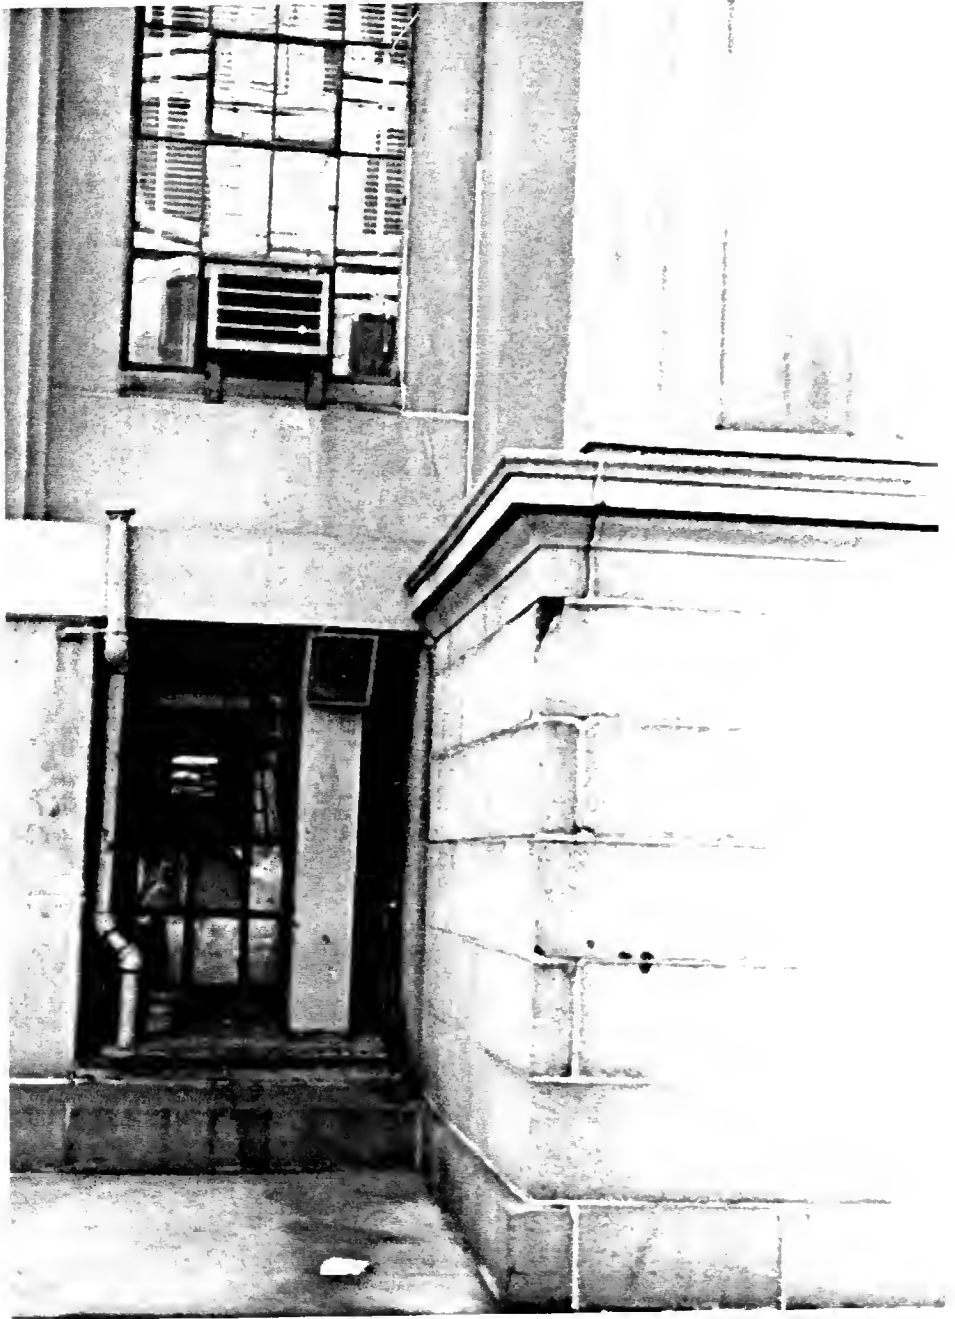
Figure 11

South end of South portico
(chipped raking cornice)

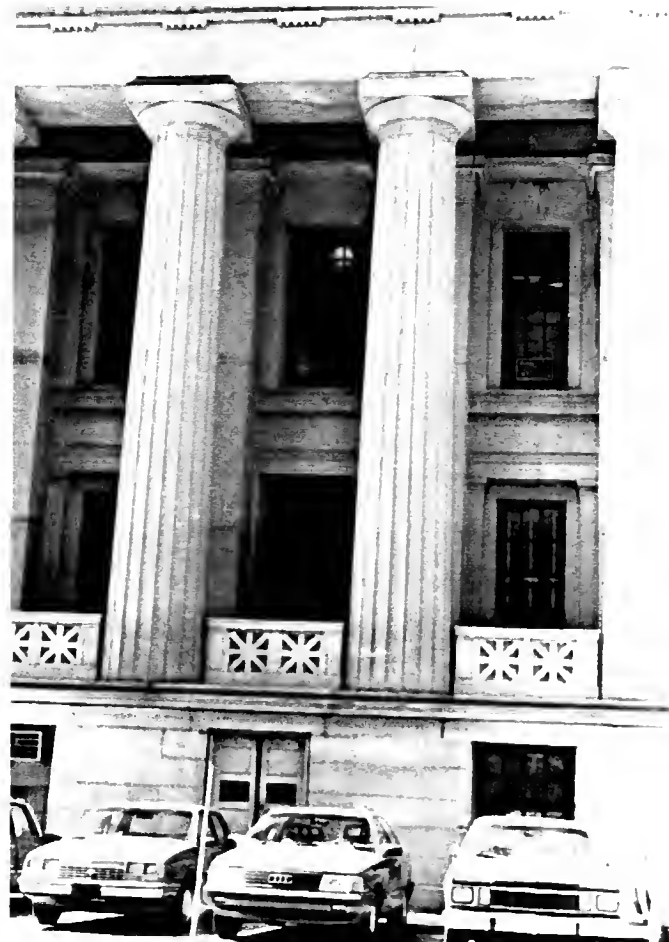
Figure 13

East portico during hard rain

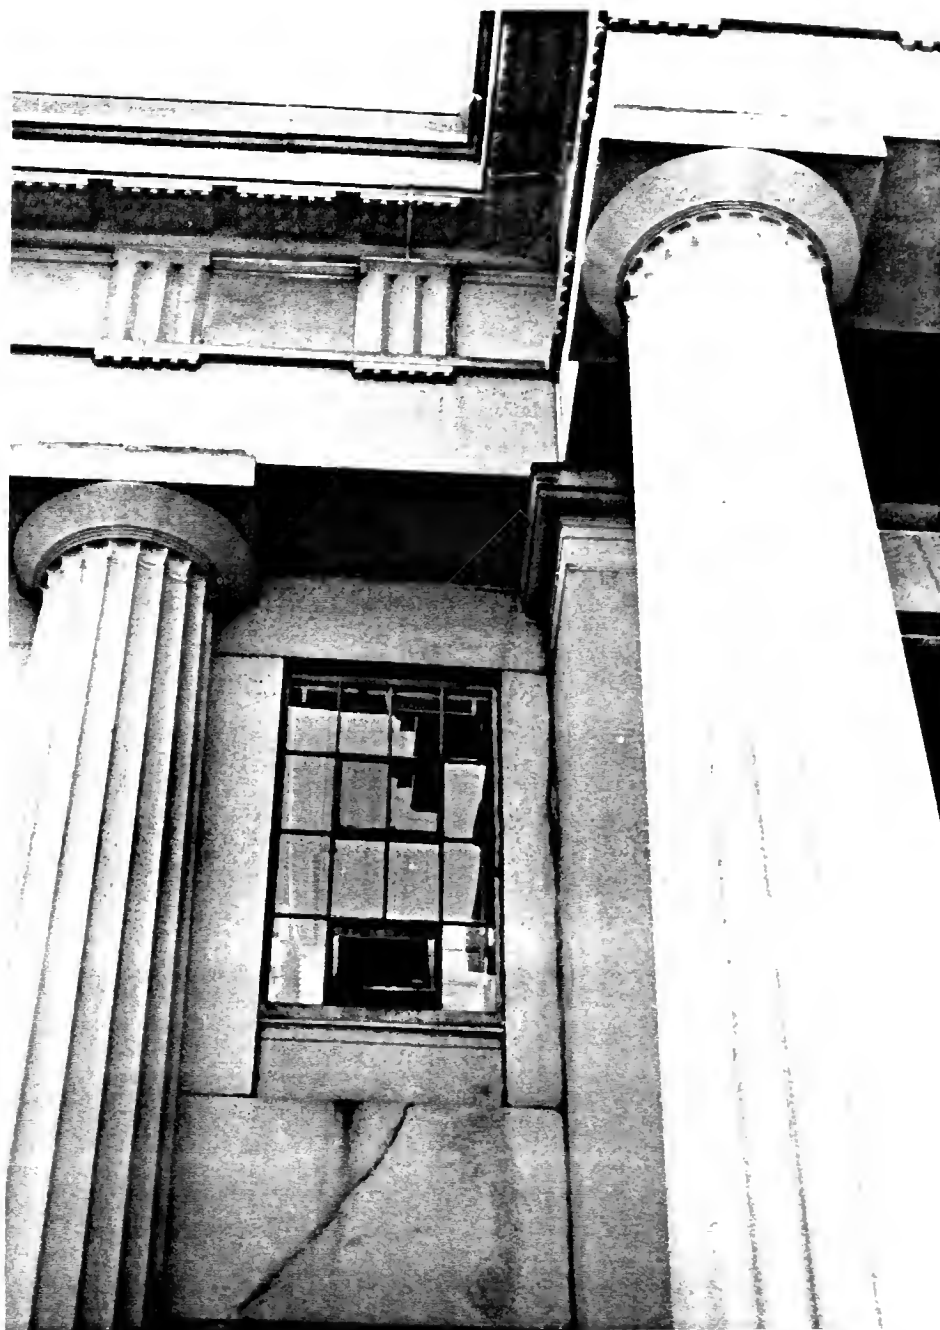
Figure 15

View of water stains in soffit,
Southern flank, East facade

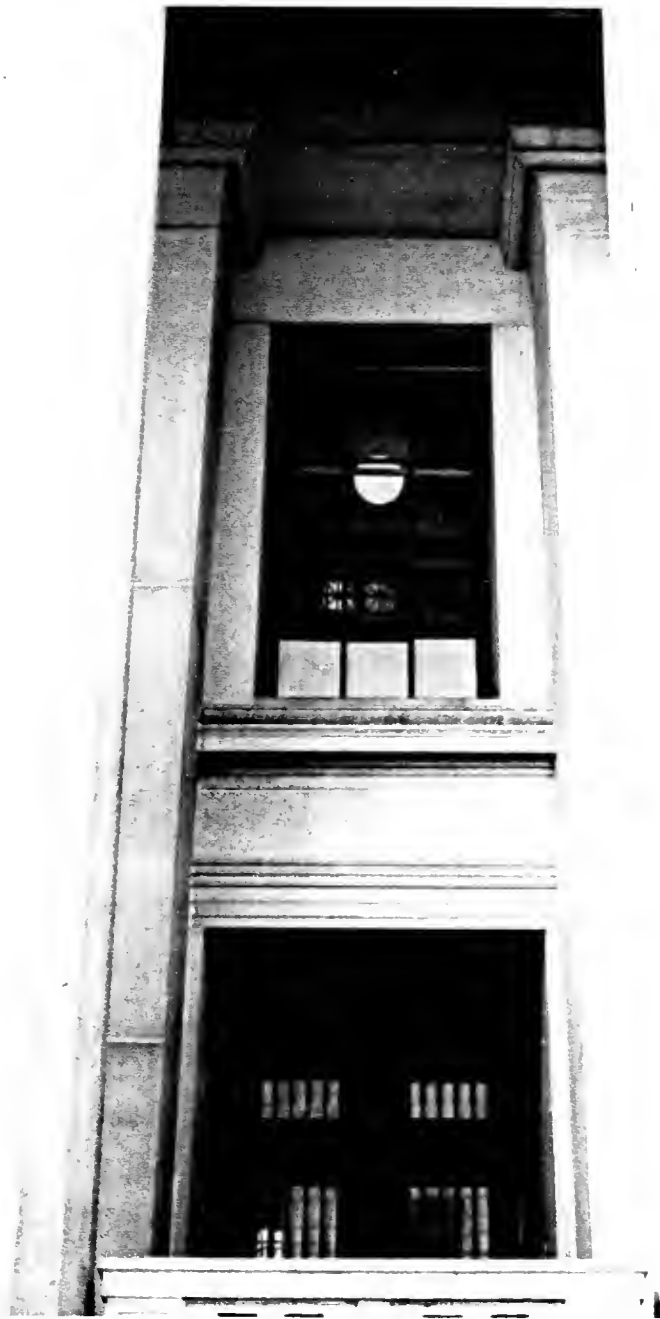
Figure 17

View of water stains, East facade,
North corner of portico

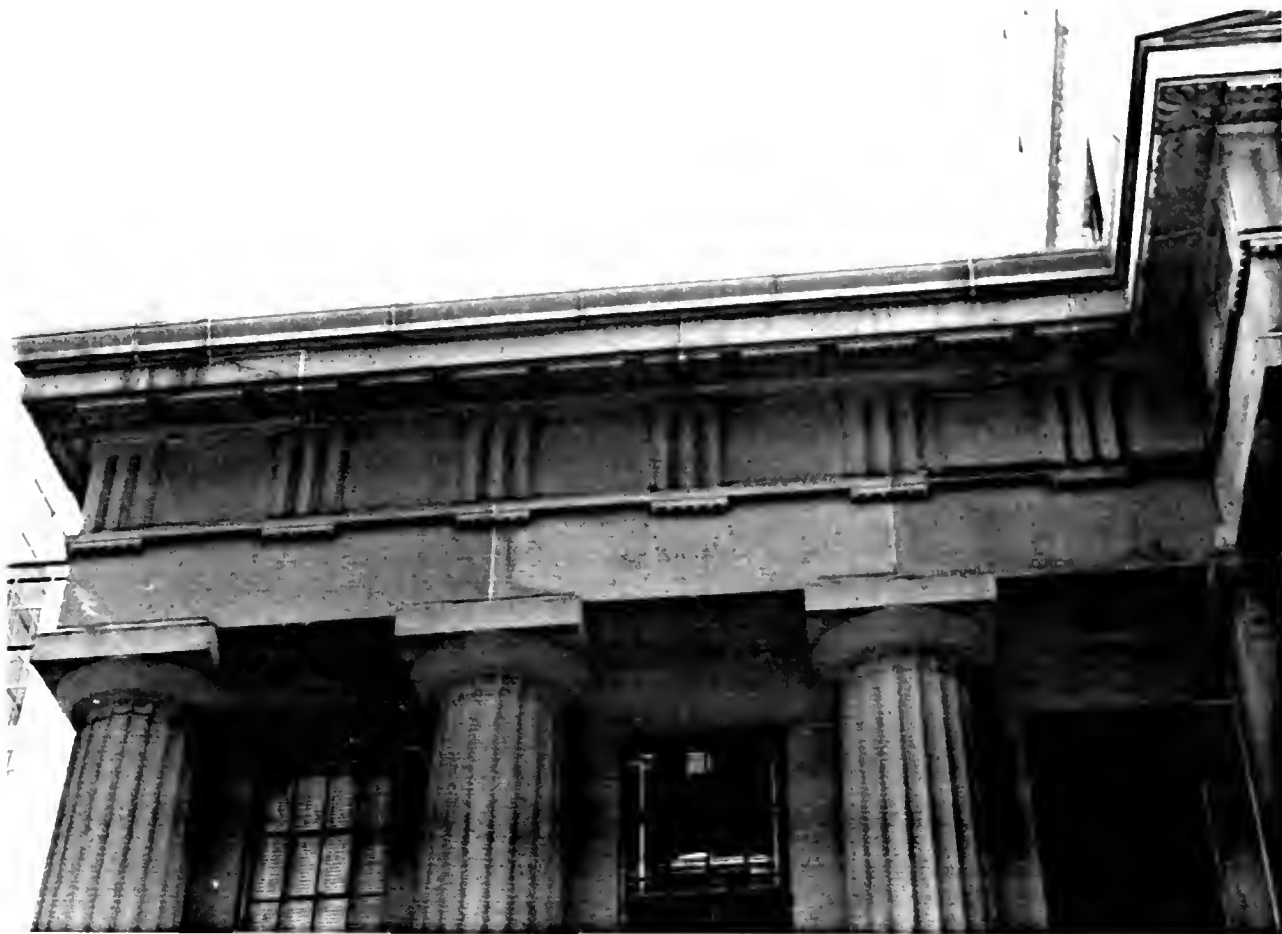
Figure 22

View of West wall
to North of West Entry

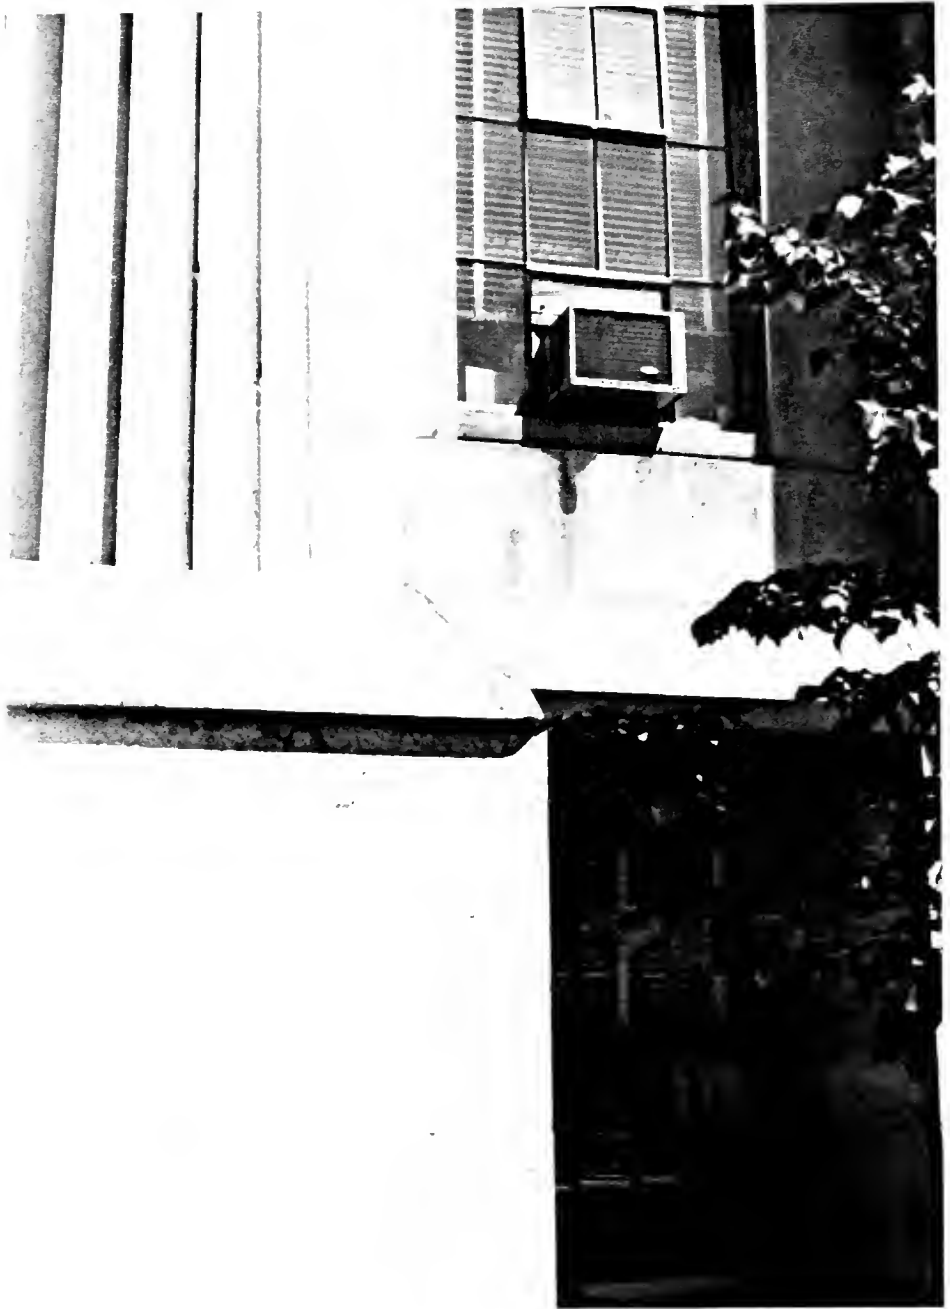
Figure 23

View of full entablature,
North portion of West wall

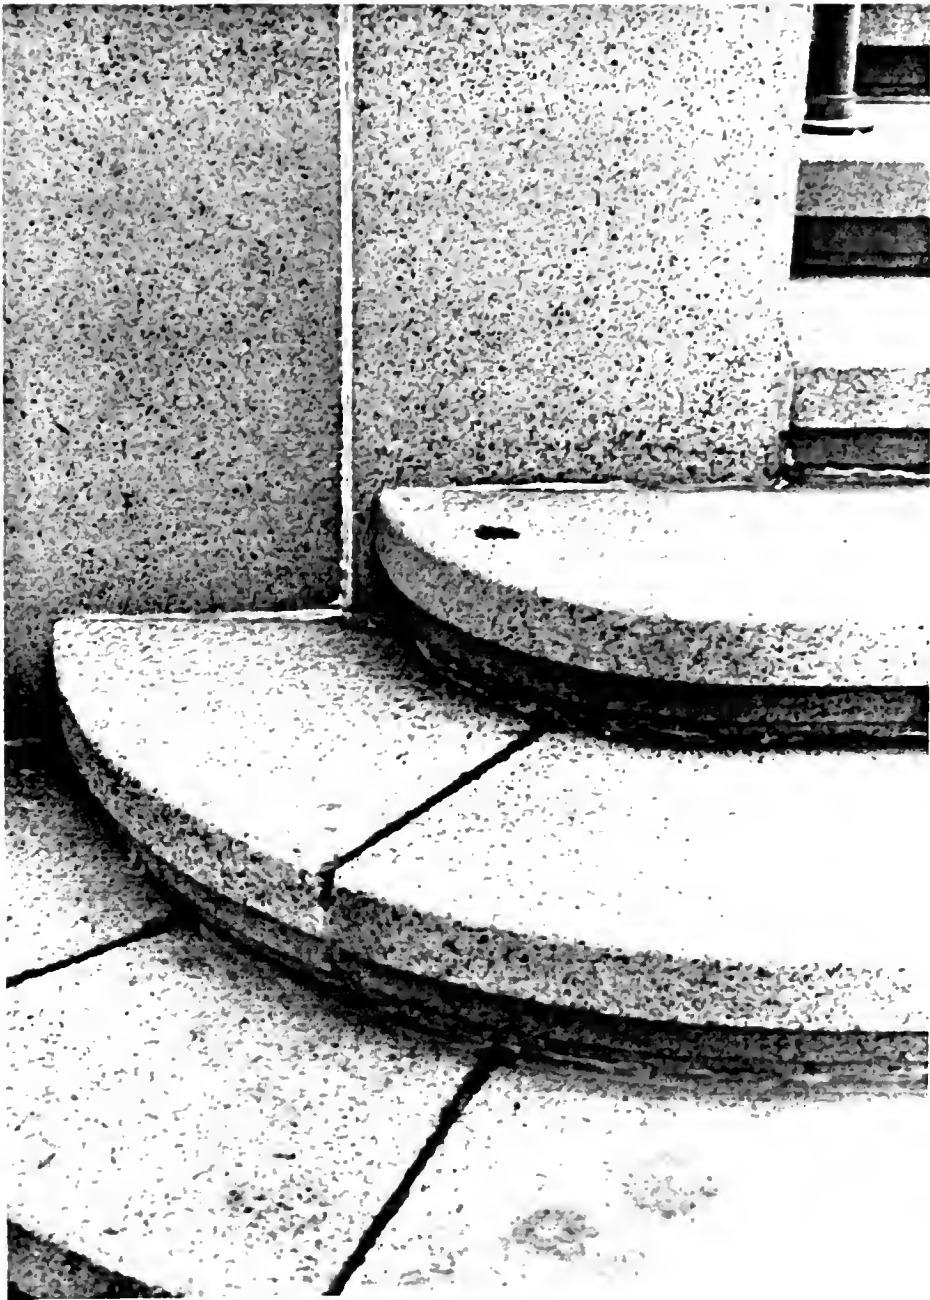
Figure 26

West Entry, 1st floor

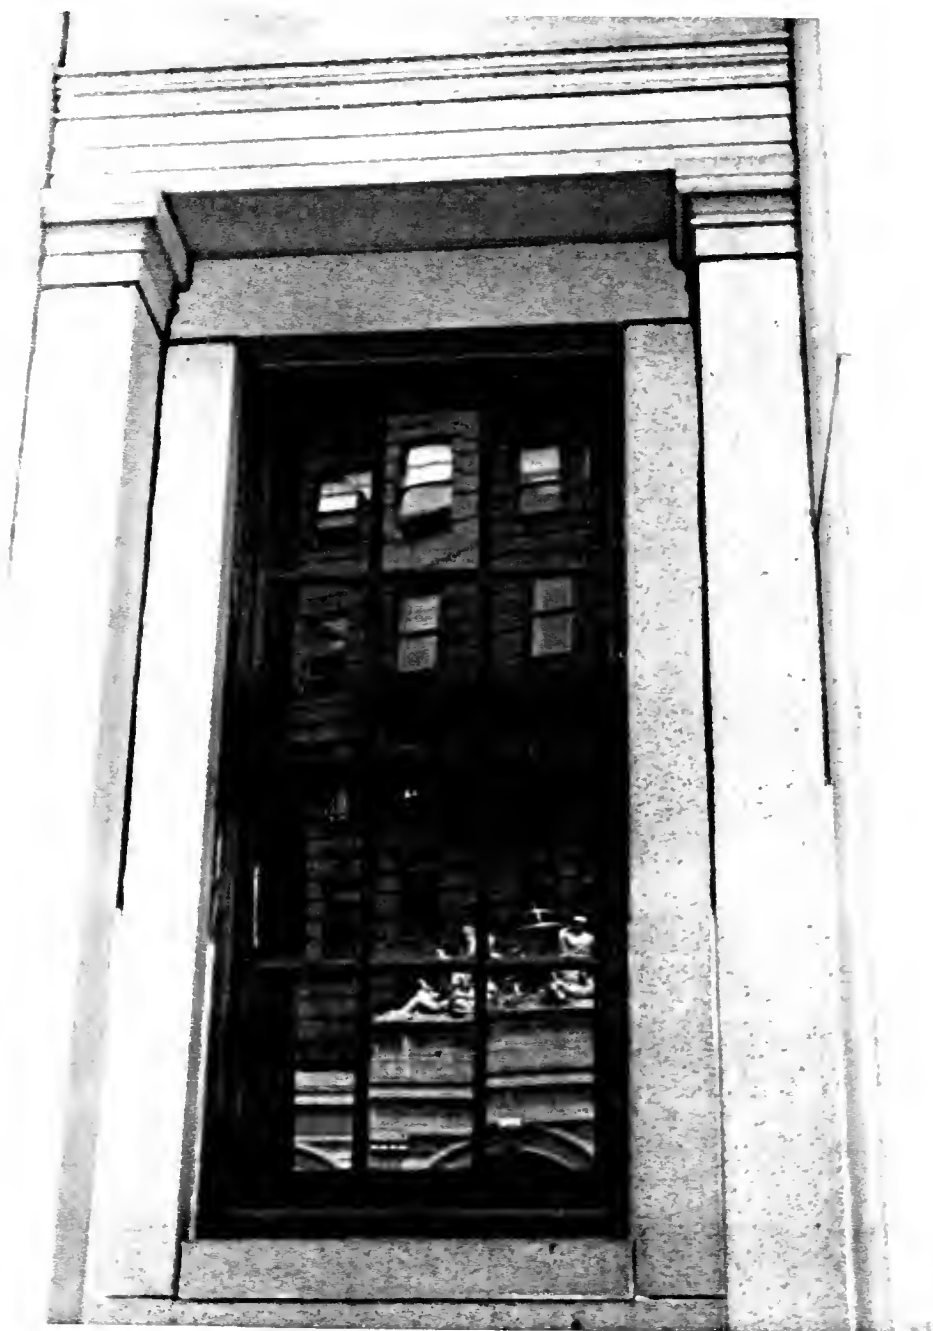
Figure 31

First Floor window, East wall
(Typical conditions)

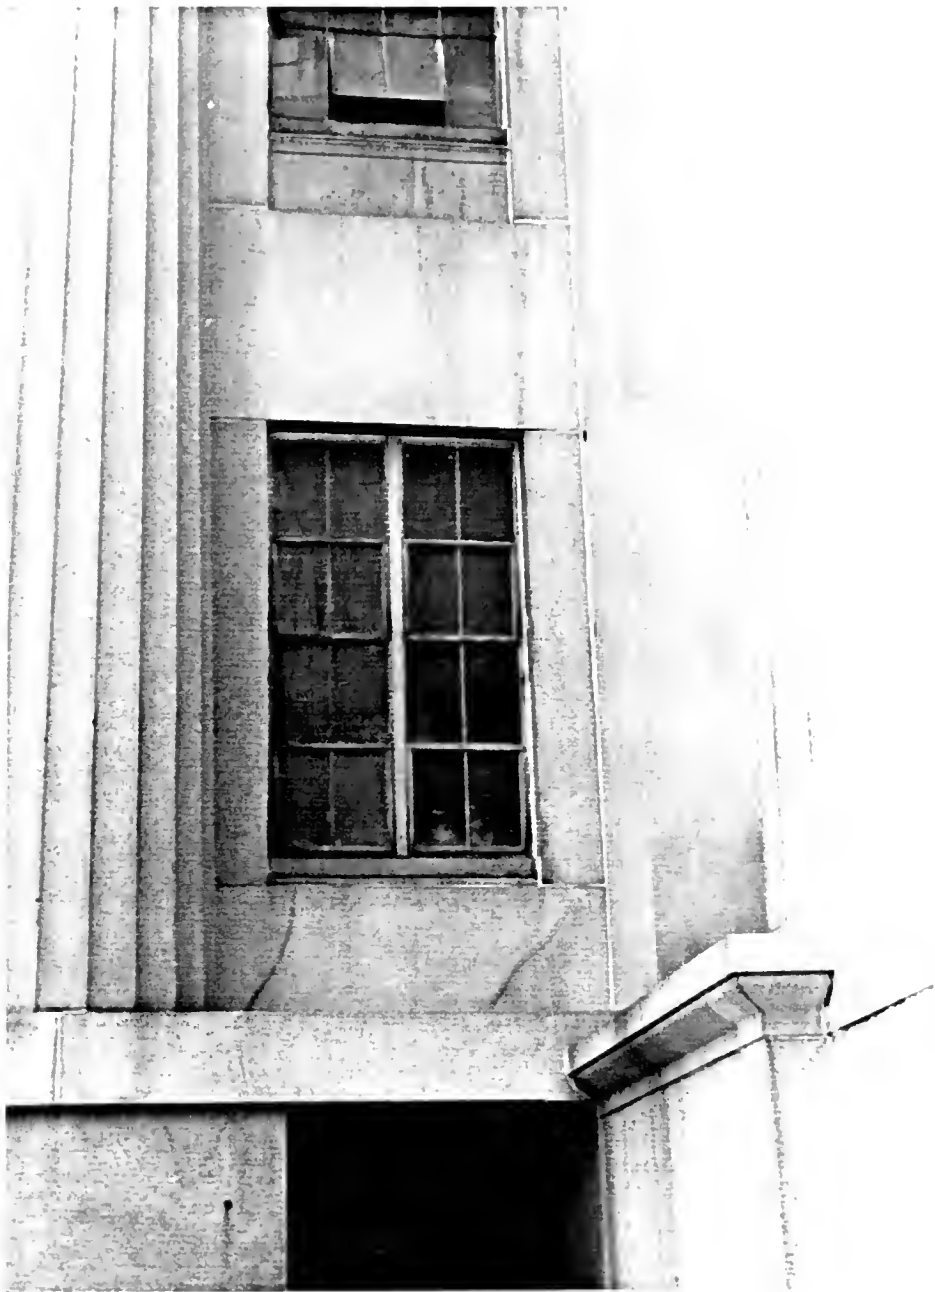
Figure 32

West wall, window over Entry (2nd floor)

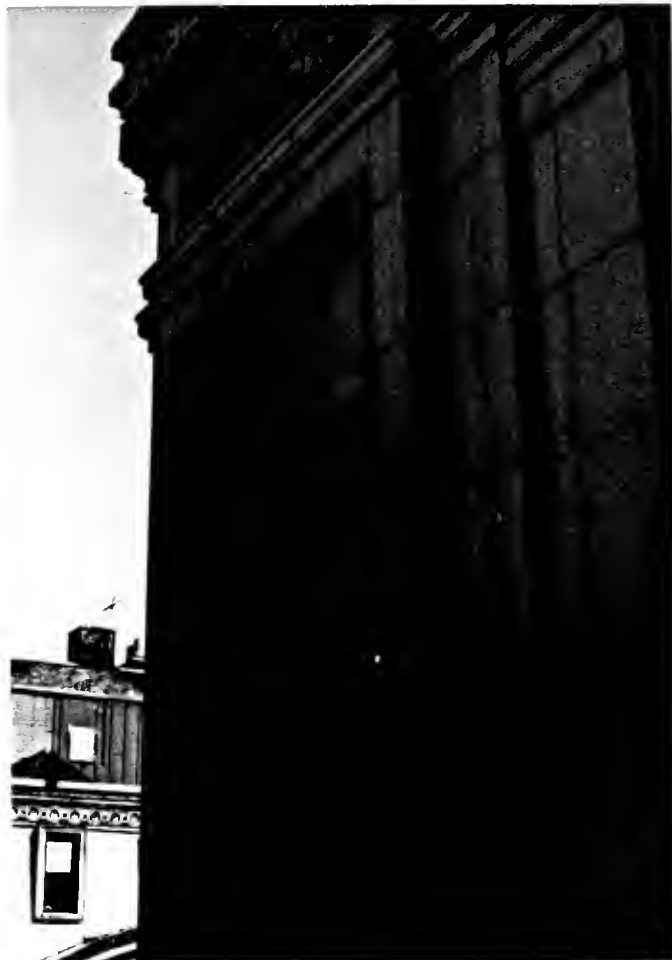
Figure 33

1st floor window on West wall,
North of Entry (Typical conditions)

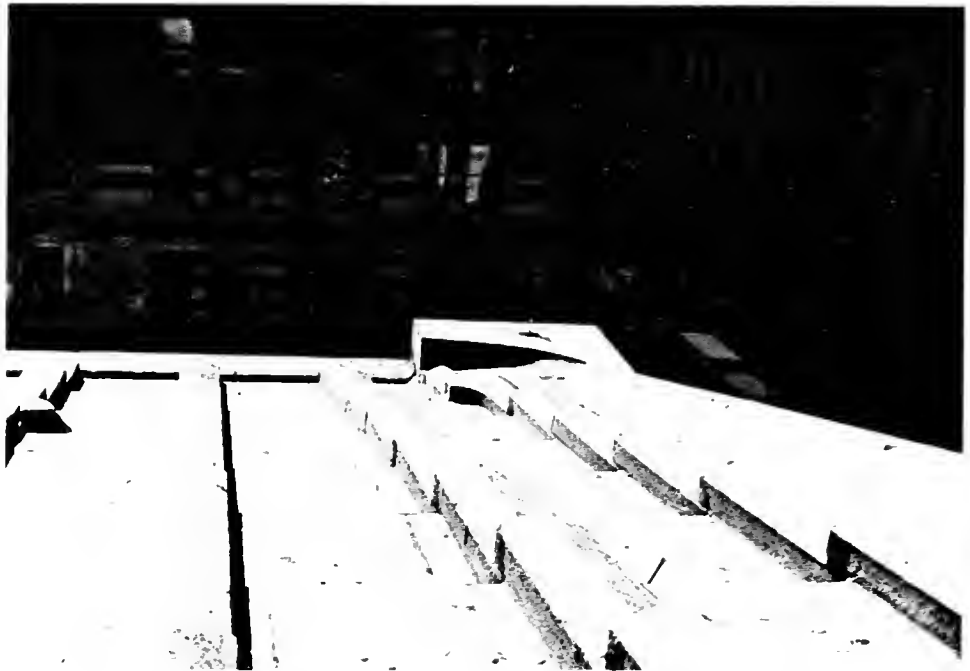
Figure 39

View of boardwalk and flag pole
North roof

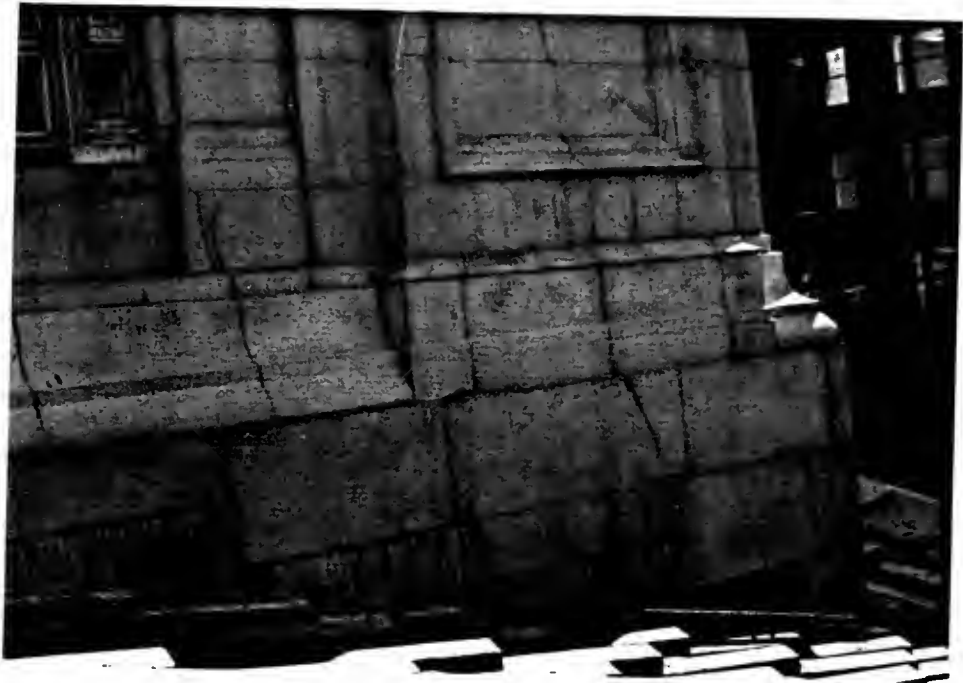
Figure 40

Northwest corner of West slope of North roof

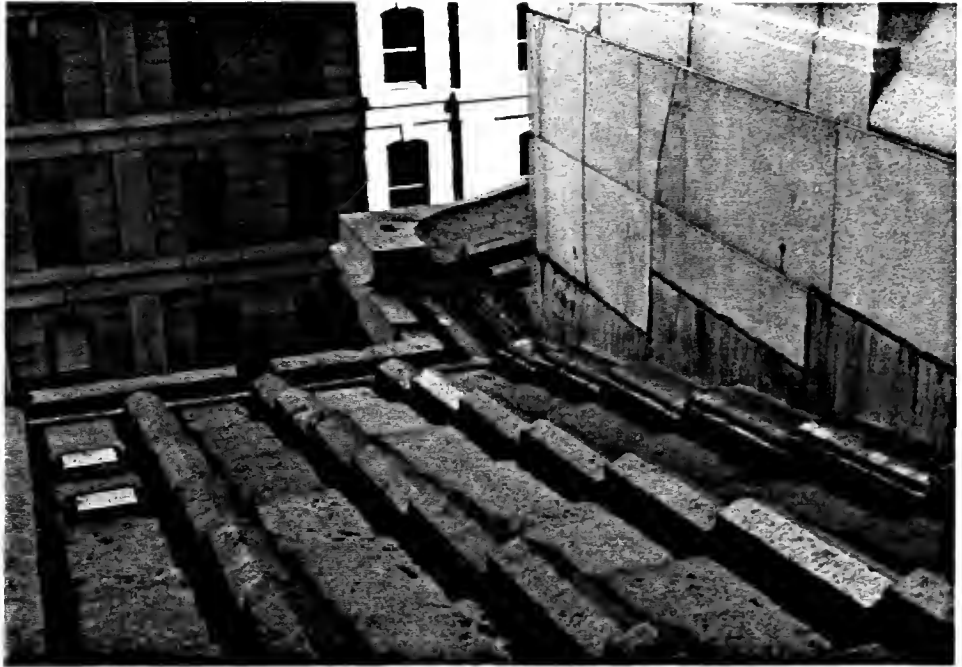
Figure 41

Flashing and stone detail on North wall
as seen from North roof boardwalk

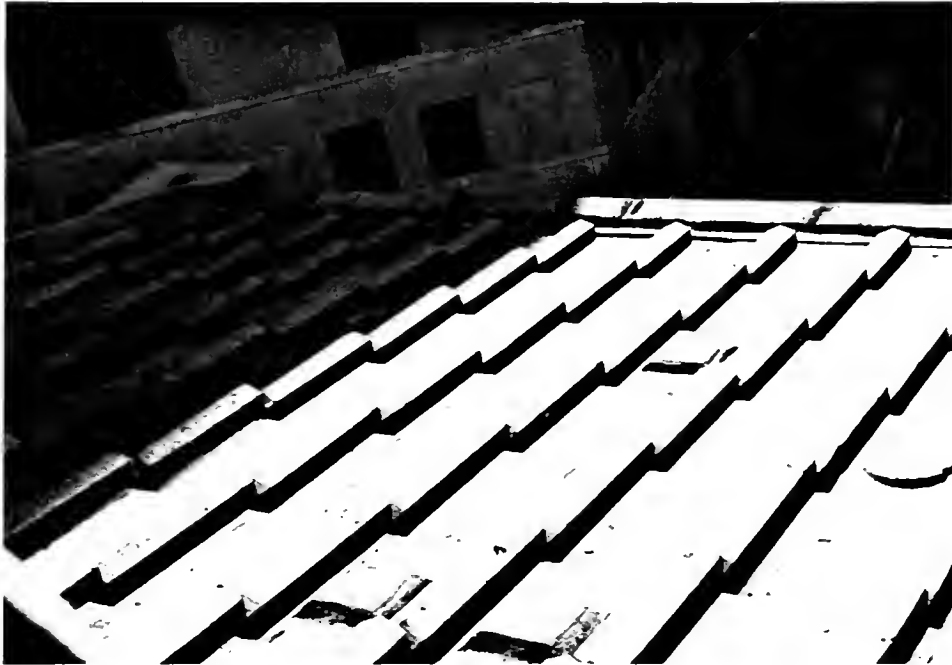
Figure 42

West slope of South roof

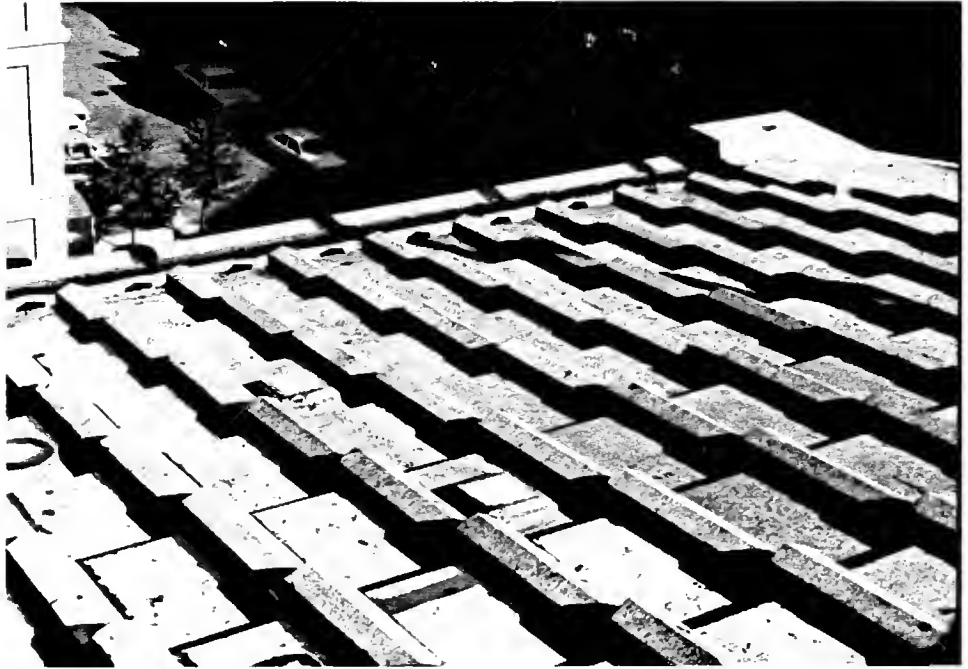
Figure 43

West slope of South roof

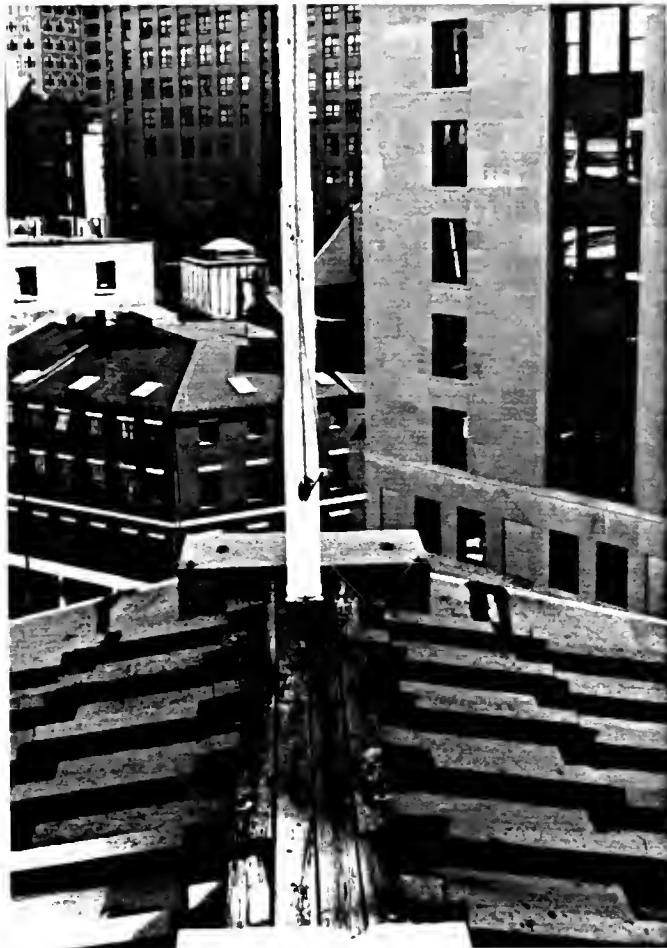
Figure 44

East slope of South roof

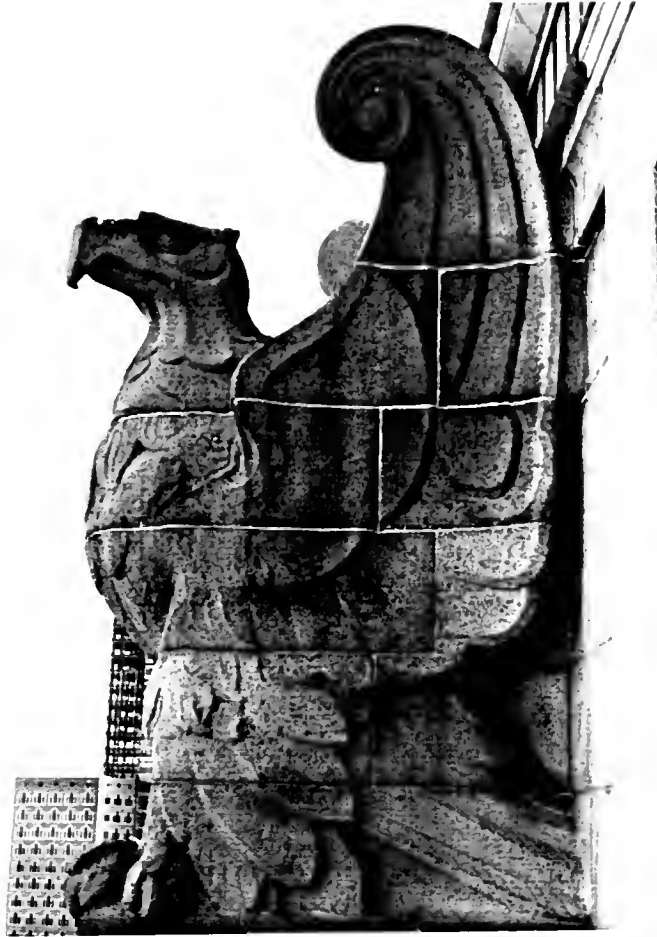
Figure 48

Eagle on Southwest corner of balcony
Floor 20

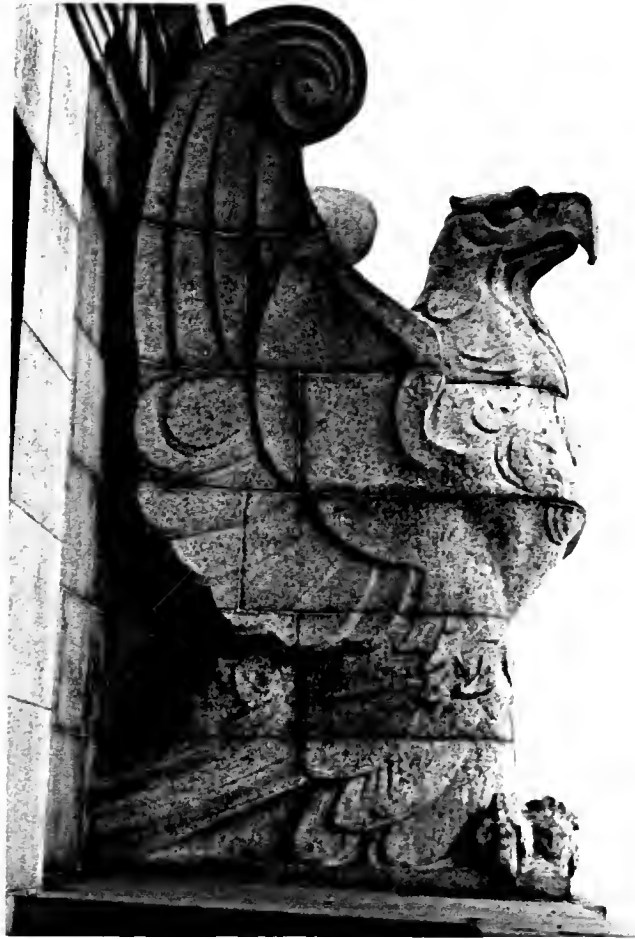
Figure 49

Eagle on Southeast corner, 20th floor.
More white caulk.

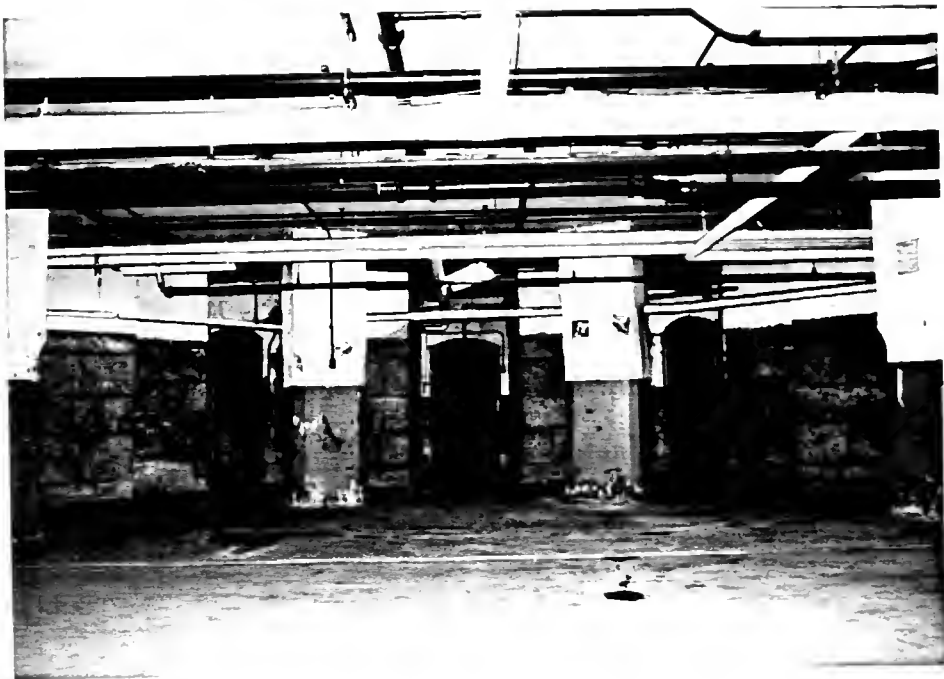
Element	Material/Description	Condition	Photo#
Floor	concrete	fair, painted at least 4 layers peeling [red, grey, lt. grey, present grey]	SB-1
Base-board	None		
Walls	granite & plaster	rough cut, painted, fair; 8 layers of paint including ivory, tan, green	SB-1,2
Cornice	none		
Ceiling	plaster	very poor - calcimine peeling	SB-1
Windows	none		
Window Frames	iron frames of sidewalk lights	very rusted	
Doors	painted metal	only 2 left	
Door Frames	painted metal	good	
Hardware	iron and steel	fair - good	SB-1
Elect. Fixt.	egg crate	fair	
Square stone columns	granite	parged w/ 2-3 1/2" layers of concrete	
Remarks: joints in walls newly pointed w/ grey cement - too wide iron frame of central frosted oculus in ceiling is corroded.

SB-1; Rotunda, looking west.

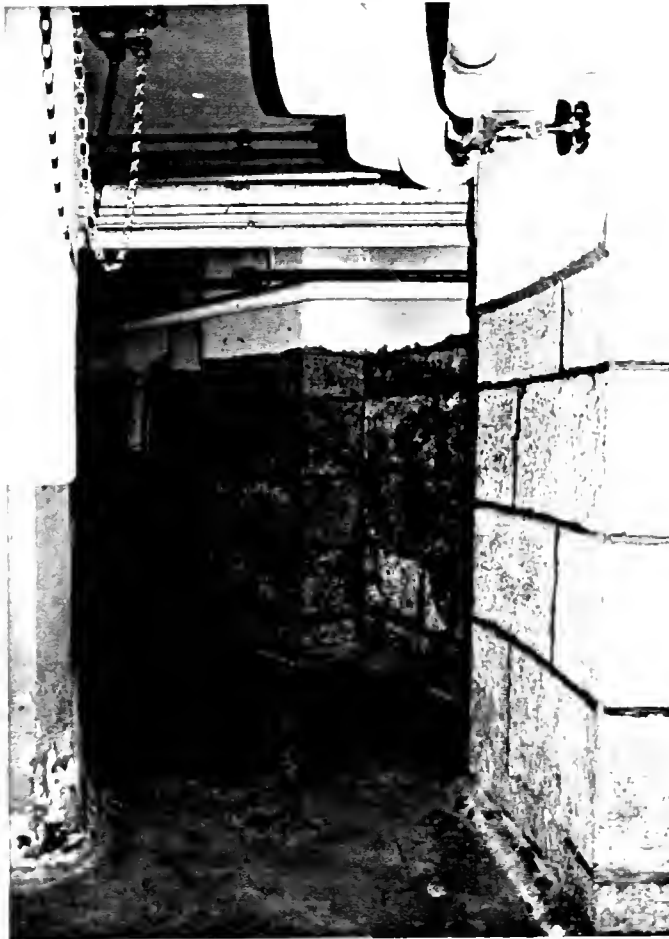
SB-2; New granite piers laid up against original granite walls of rotunda.
